Sangre de Cristo Arts Center **Site Remediation Recommendations**

ATRIUM SITE REMEDIATION

SANGRE de CRISTO ARTS AND CONFERENCE CENTER

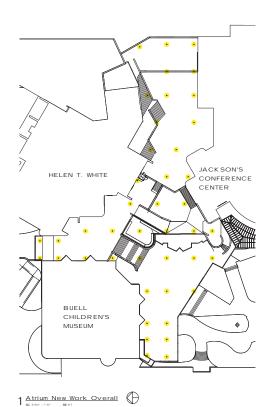
PIER LOCATIONS (estimates)

DRAWINGS SHOW APPROXIMATE LOCATION OF PILLARS ONLY FOR SCHEMATIC DESIGN INDICATED BY THIS SYMBOL: 0

Construction includes 40 supporting pillars driven to 29' Pierre Shale intersection.

40 Helical PiersSITE STABILITY

40 Supporting PillarsLOAD DISBURSEMENT
& STABILITY
